## **Ecology Report & Opportunities for Enhancement**

### **Ferrensby Village Pond**

**May 2019**

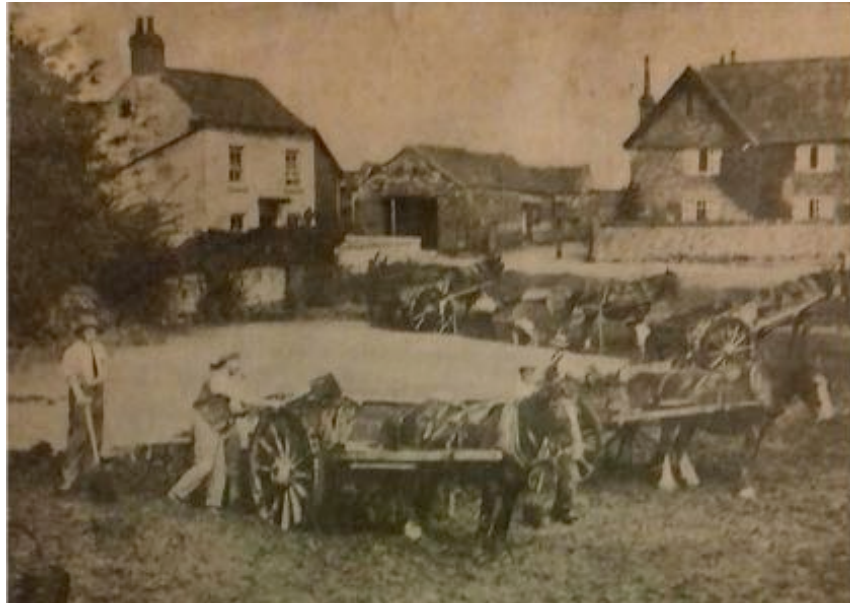
Photo 1: View looking northwest over the pond circa early 1900s. A local resident has said he believes the photo shows men removing sediment from the pond when the pond dried up.

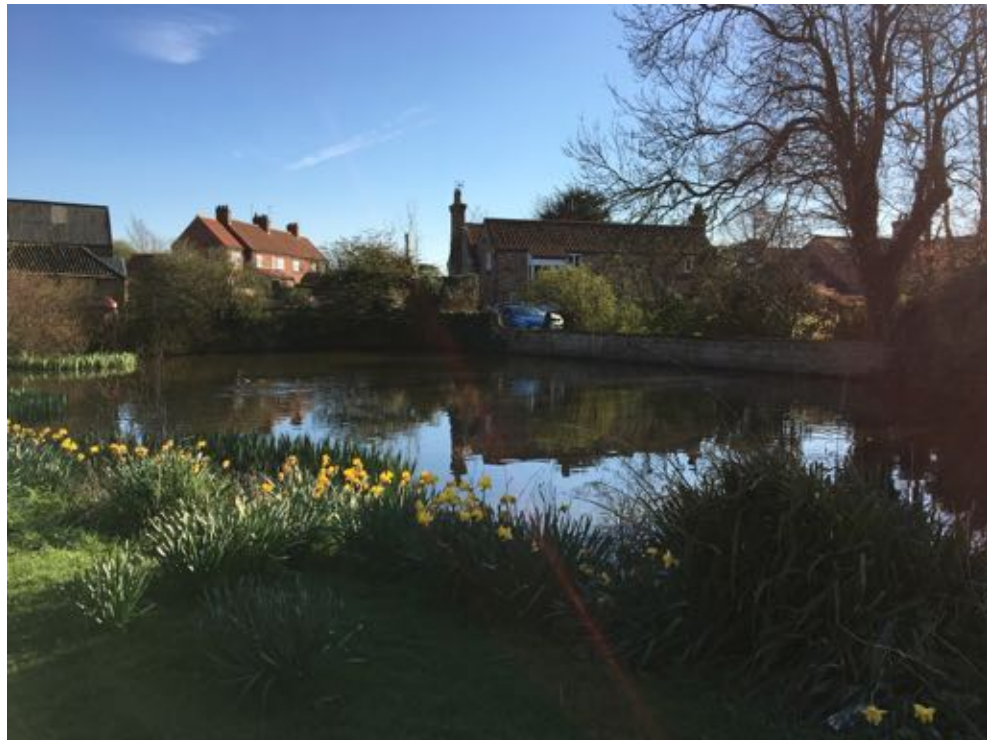
Photo 2: Pond looking southwest towards pond wall and Harrogate Road.

- 2.2.2 The banks to the pond have been reinforced with stone to the north and east in the past and this is now collapsing. Walls to the west and south are stone built vertical retaining walls and appear sound.

- 3.2.8 Large stone has been used in the past to stabilise the banks of the pond to the north and east however this has now collapsed.
- 3.2.9 It is not clear why the existing stone reinforcement has collapsed as there is no evidence to suggest active erosion to the east bank while there is some erosion to the north bank where the bank gently grades in to the pond.
- 3.2.10 In the event that the banks do require stabilisation it may be possible to use green gabion baskets.
- 3.2.11 Gabion baskets are rigid wire baskets filled with laid stone. They have a longer life than simply laying stone and can now be lined with coir (or similar) to soften. However, this is unlikely to be a cheap option.
- 3.2.12 The baskets can be planted but if backfilled with soil however any planting will need to consider grazing ducks.

- 3.2.13 Gabion baskets are unlikely to be a cheap option and it is advised that further investigation is undertaken to determine the need for reinforcement. It is accepted that investigation may have already been undertaken and the need and the need confirmed.
- 3.2.14 Any in-pond works must avoid the breeding bird season to avoid disturbance to breeding birds.

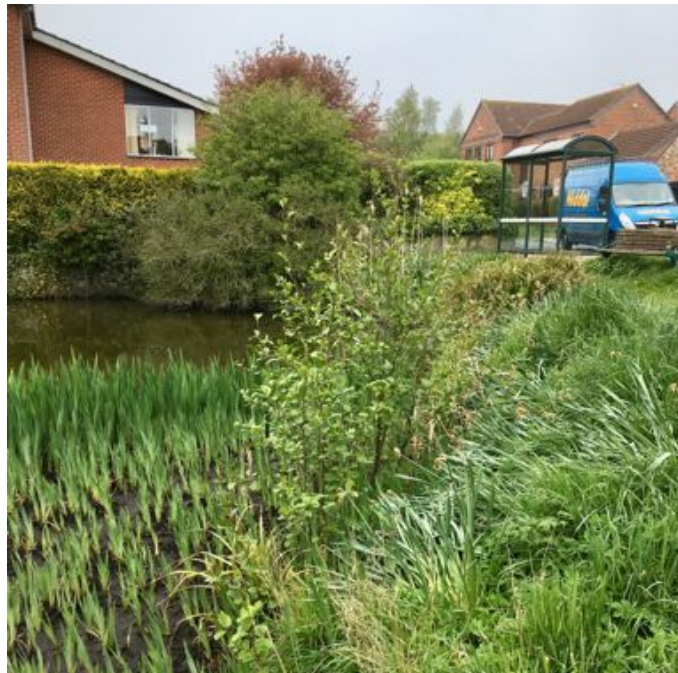
- 2.2.6 To the edge of the open water on the north and eastern side of the pond, rafts of Yellow flag iris (*Iris pseudacorus*) have developed over the last couple of decades - perhaps where the collapsing stone bank has accumulated sufficient substrate (through decaying material) in which the Iris can root (See photo 3).
- 2.2.7 The robust Iris rhizomes will be resistant to trampling by ducks and the softer parts of the plant are known to be unpalatable to ducks.
- 2.2.8 During all surveys these Iris rafts where exposed above the water level. At the interface between the iris rafts and the bank occasional Alder has managed to root.

Photo 3: View looking to the northwest showing Alder rooting at interface of iris raft and bank.

- 3.2.17 The Iris rafts that have developed to the eastern edge of the pond creates a sinuous edge which serves to lengthen the pond edge and also adds structure to the pond.
- 3.2.18 Iris is known as a vigorous pond plant and can become invasive if not managed. However, Google Earth shows that the plant has only spread slowly since 2002 when the rafts are barely visible on Google earth.
- 3.2.19 It is considered that there is no imminent requirement to remove the Iris at the present time however, it should be monitored. Yellow flag iris does not grow in deep water i.e. does not grow in water deeper than approx. 30cm. and this may serve to constrain further spread of the plant. If, however sediment is building up within the pond or

decaying matter accumulates (as it will be in the rafts) the Iris will find opportunity to spread.

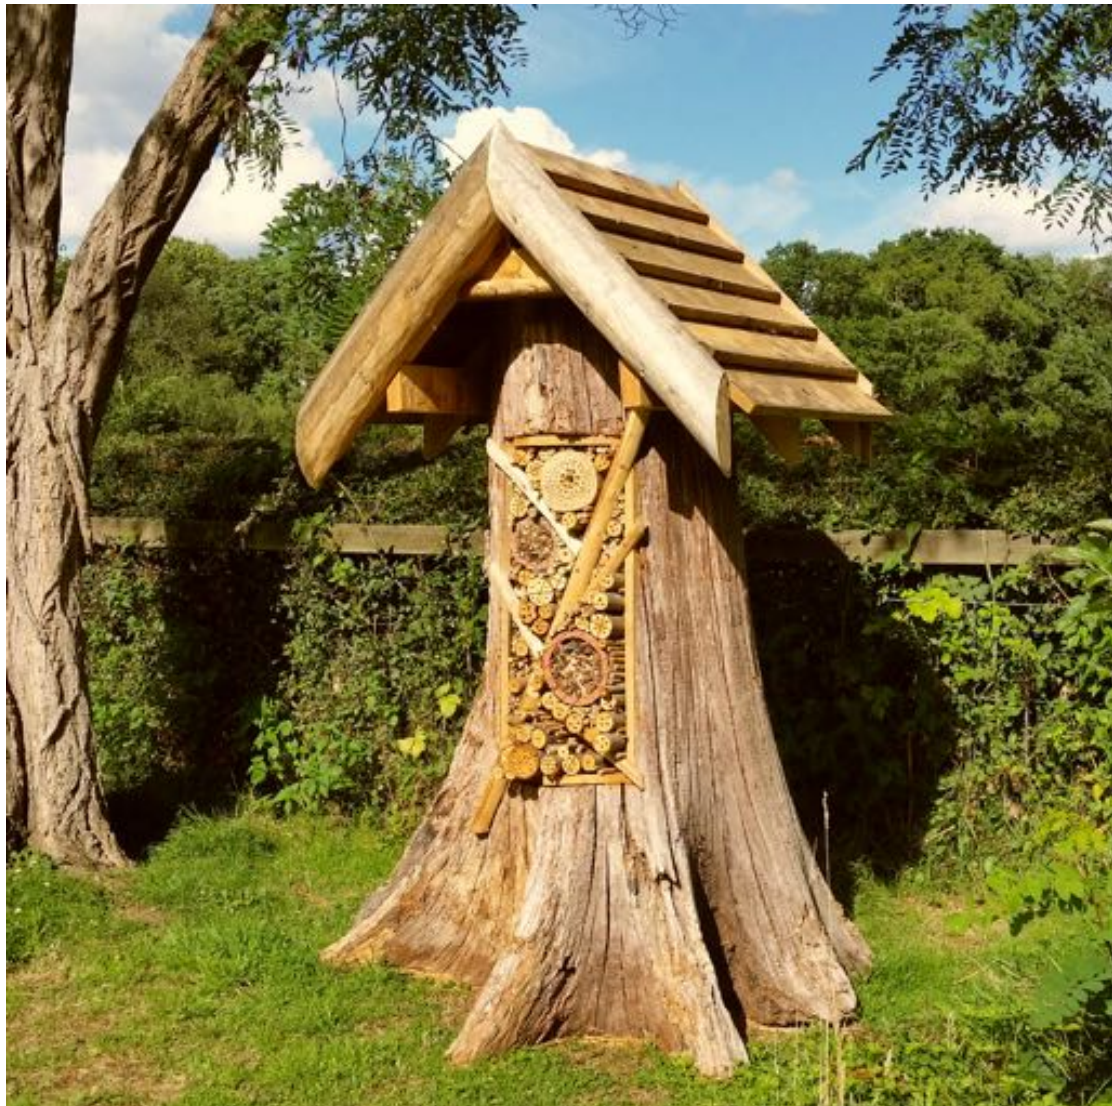
A wonderful example of Bug hotel 5\*

- 3.2.26 A somewhat more unusual idea is a local competition to design a sculpture/ structure of bird boxes and small scale bug hotels. The winning sculpture, being made by a local handy person and erected to the ground around the pond.
- 3.2.27 The sculpture would need to be positioned in an area where it receives some sunlight, at least dry in some areas, away from exposed areas/ sheltered and safe from vandalism and able to be secured to the ground or a wall.
- 3.2.28 The sculptural design should be driven by maximising opportunities for wildlife including pollinators and birds.
- 3.2.29 There are numerous designs for bug hotels to be found on the internet.
- 3.2.30 One of the best big hotels I have seen is shown below, designed and made by Conservation and Access based in the south of England.
